Article

Profiling Corrosion Rates for Offshore Wind Turbines with Depth in the North Sea

Keywords: North Sea; mass loss; chemical analysis; corrosion rate; sea depth

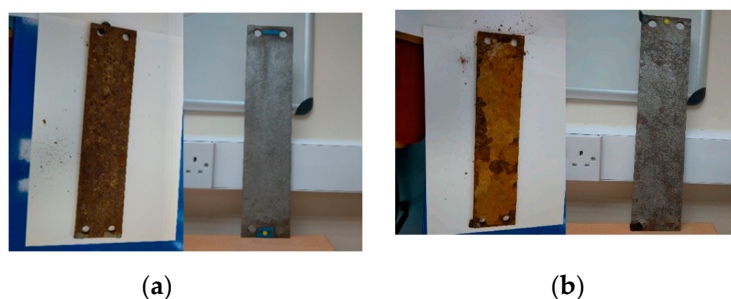
Figure 7. Samples: (a) before cleaning, (b) after cleaning.

The plates were cleaned according to the ASTM G1 standard where 1000 mL HCl, 20 g antimony trioxide (Sb_2O_3), 50 g stannous chloride (SnCl_2) were used and shown in Figure 7a,b [28].

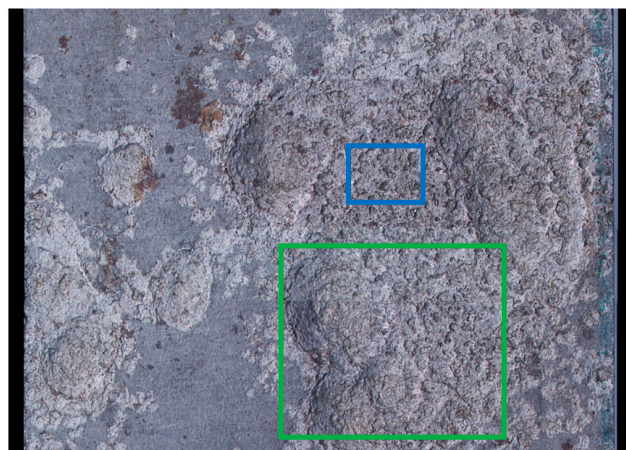
Figure 9. Pit coalescence highlighted in green and micro pits highlighted in blue.

It was estimated for instance in the 3-black case that the number of pits on the front side was more than that on its back side. This difference is hard to explain due to a variety of factors that have affected the experiment. This observation has to be re-tested though to come out of the hypothetical shell to a scientific explanation with appropriate instrumentation such as the water velocity, the corrosion current and the biological and chemical influences of the water combined together in the complex sea water without the failure of the ropes and the depth preserved. The surface was more rugged as shown by Figure 9 when pitting corrosion seemed to be the dominating form of corrosion.
